## Introduction:

## Repair of Wall R2 (ongoing):

## Repair of Wall R1:

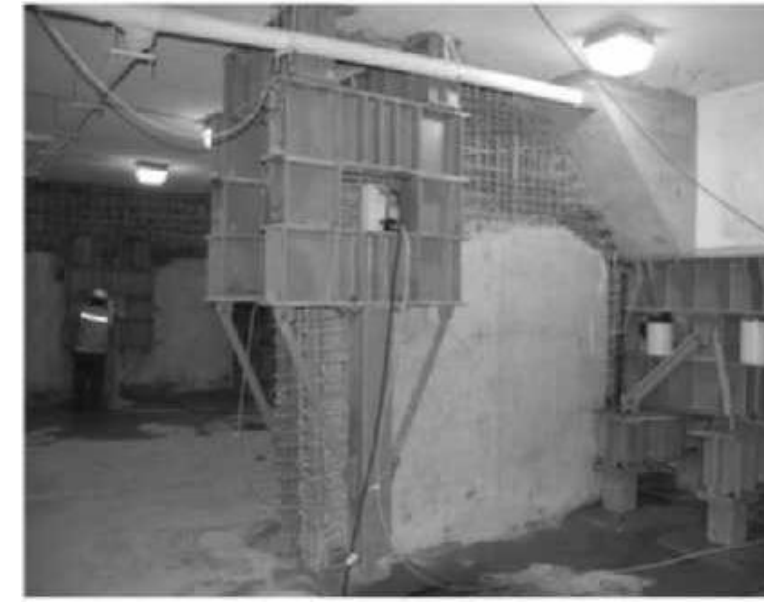
Wall repair, Chile 2010 (Sherstobitoff et al 2012)

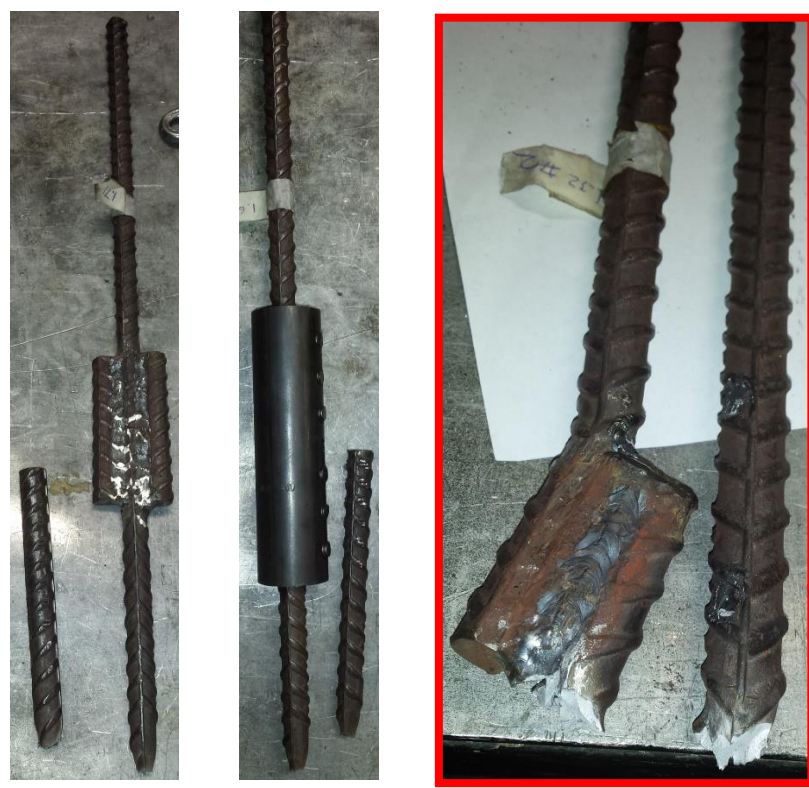
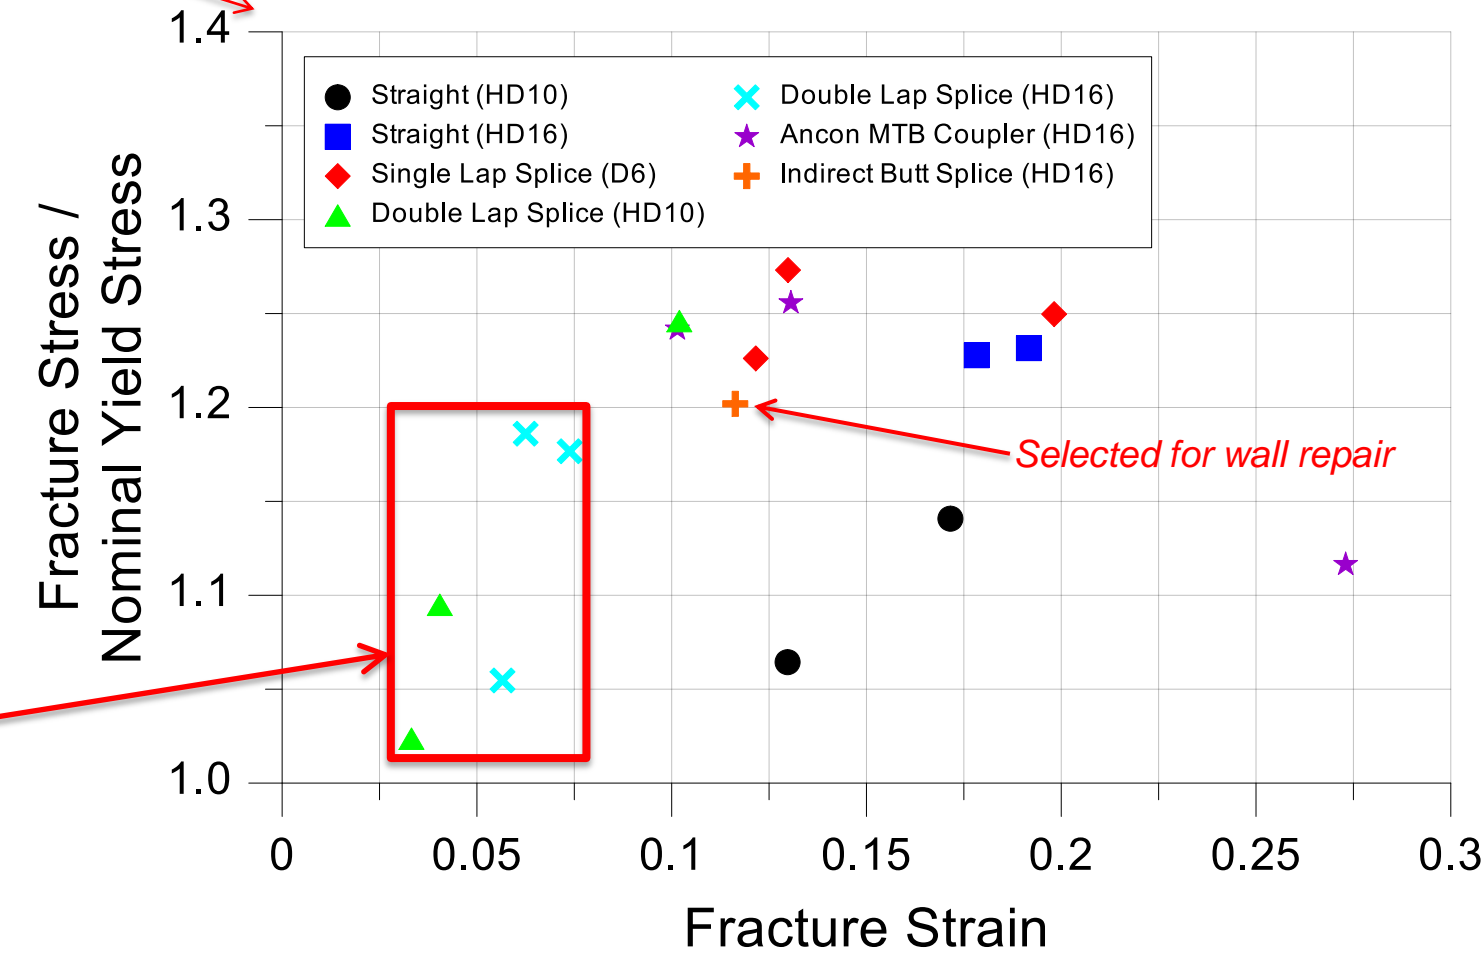
Failure did not occur at weld, except for lap splices

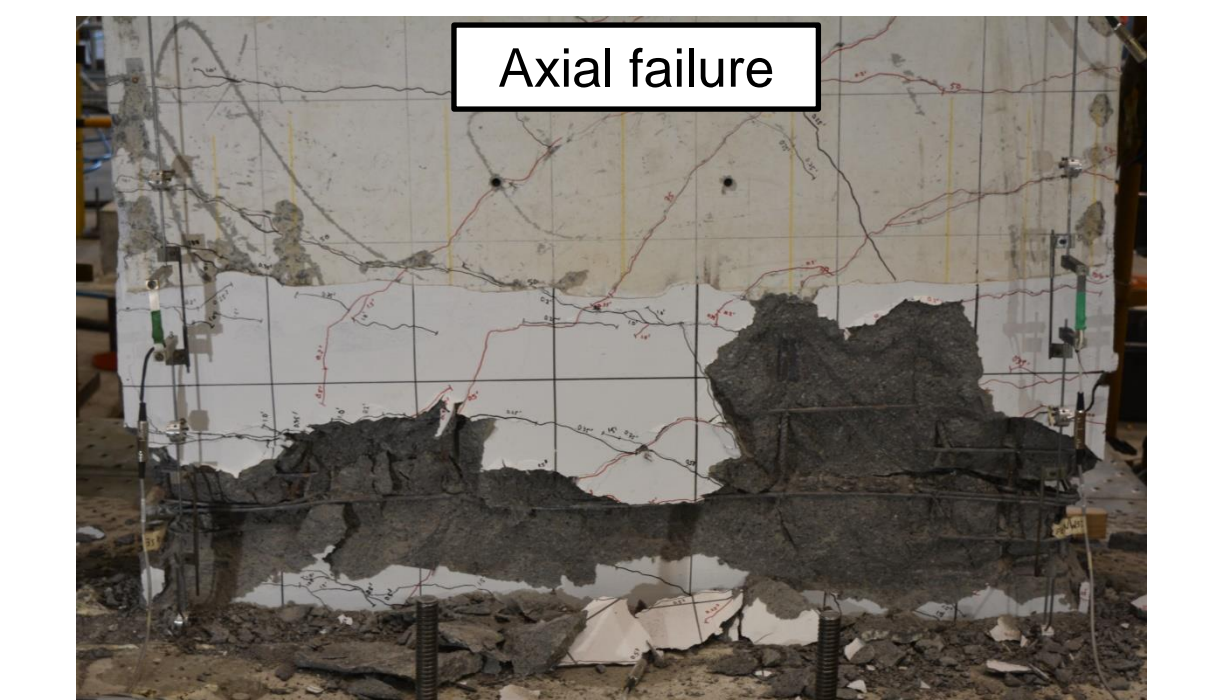
Axial failure
